Annual Inspection Report		Page No. 1 of 1
<i>Inspection and report meeting the requirements of Part 257.84(b)</i>		
Merrimack Station Ash Landfill	Location: Bow, New Hampshire	Year: 2025 File No. 2025.17
Date of Inspection:	January 16, 2026	Volume of CCR in place: 227,700 cubic yards
Completed by:	Harrison R. Roakes, PE	
Changes in landfill geometry since previous annual inspection? Yes <input type="checkbox"/> No <input checked="" type="checkbox"/> <i>If yes, please explain below.</i>		
Observed actual/ potential structural weakness? Yes <input type="checkbox"/> No <input checked="" type="checkbox"/> <i>If yes, please explain below.</i>		
Observed existing conditions that are disrupting/could disrupt the operation and safety of the facility? Yes <input type="checkbox"/> No <input checked="" type="checkbox"/> <i>If yes, please explain below.</i>		
Other Observations:		
<ul style="list-style-type: none"> Material was added to the active face of the landfill by constructing benches. There was some erosion of benched materials on the active face, and the eroded material washed into the existing lined cell that includes leachate collection. Placement of additional material should conti

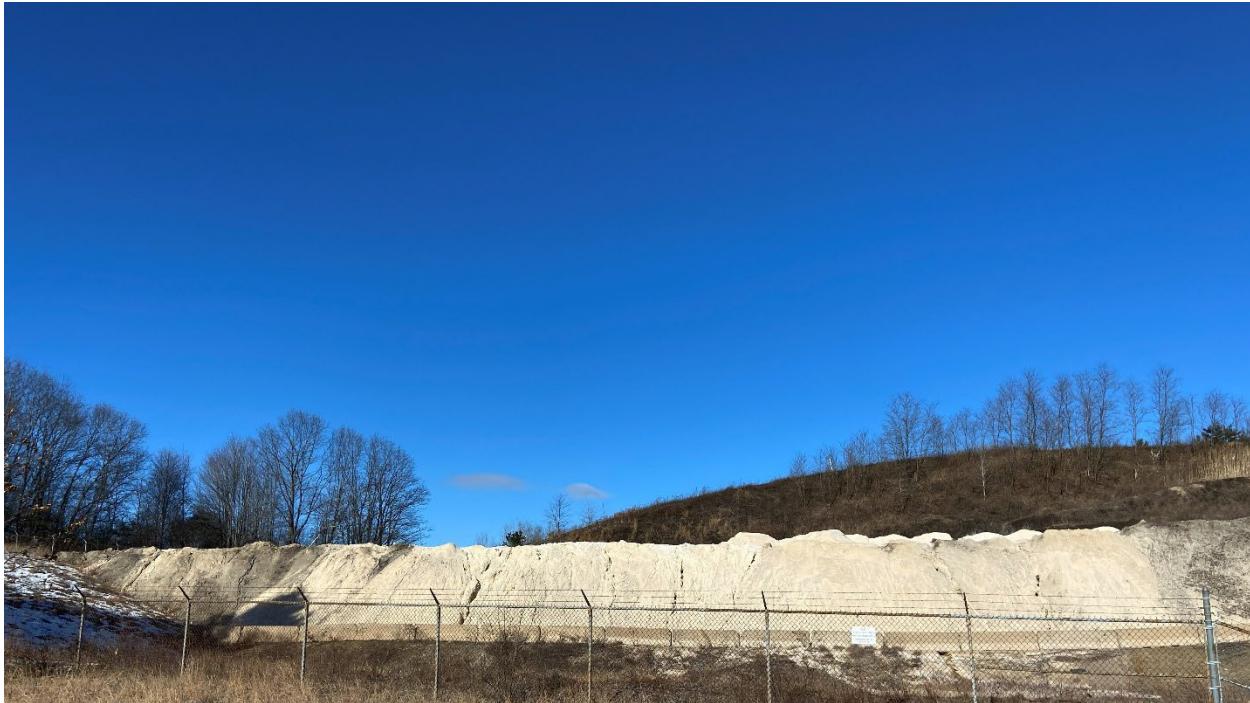
Photo 1: Landfill working face in the background and perimeter fence near leachate collection tanks in foreground. The photograph was taken looking north.

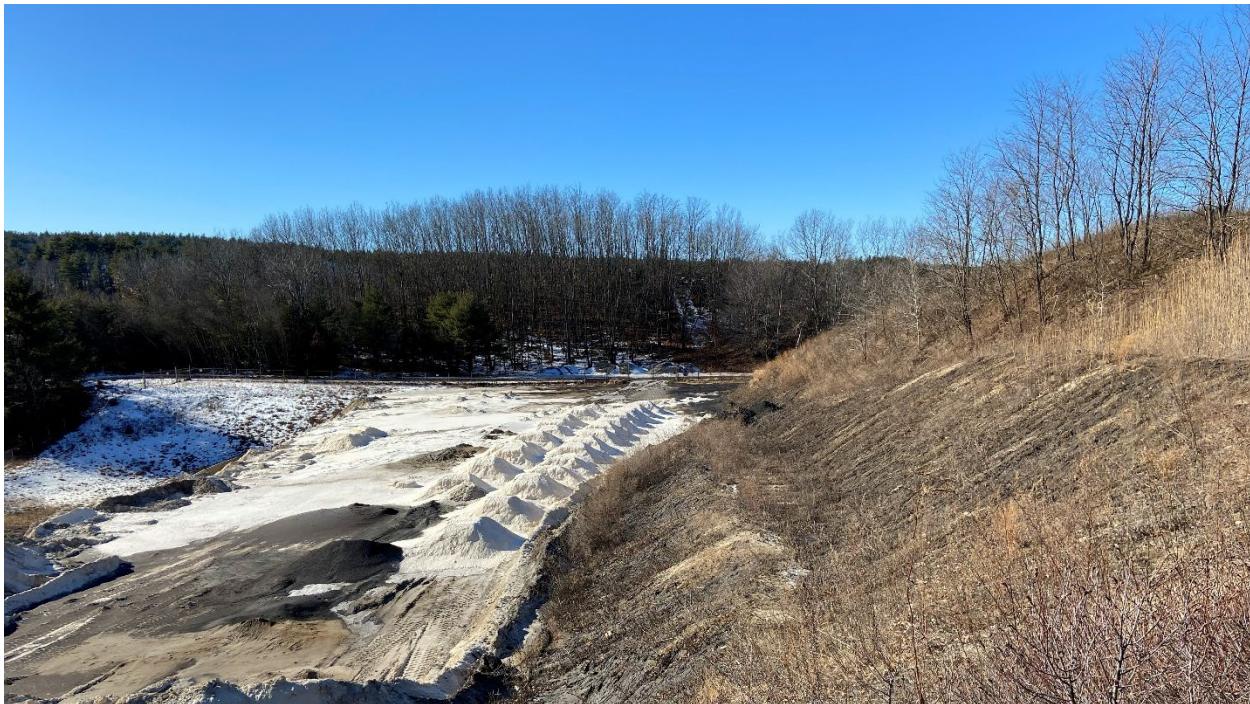
Photo 2: Landfill working face with benched slope constructed. The photograph was taken from near the top of the active cell and looking west.

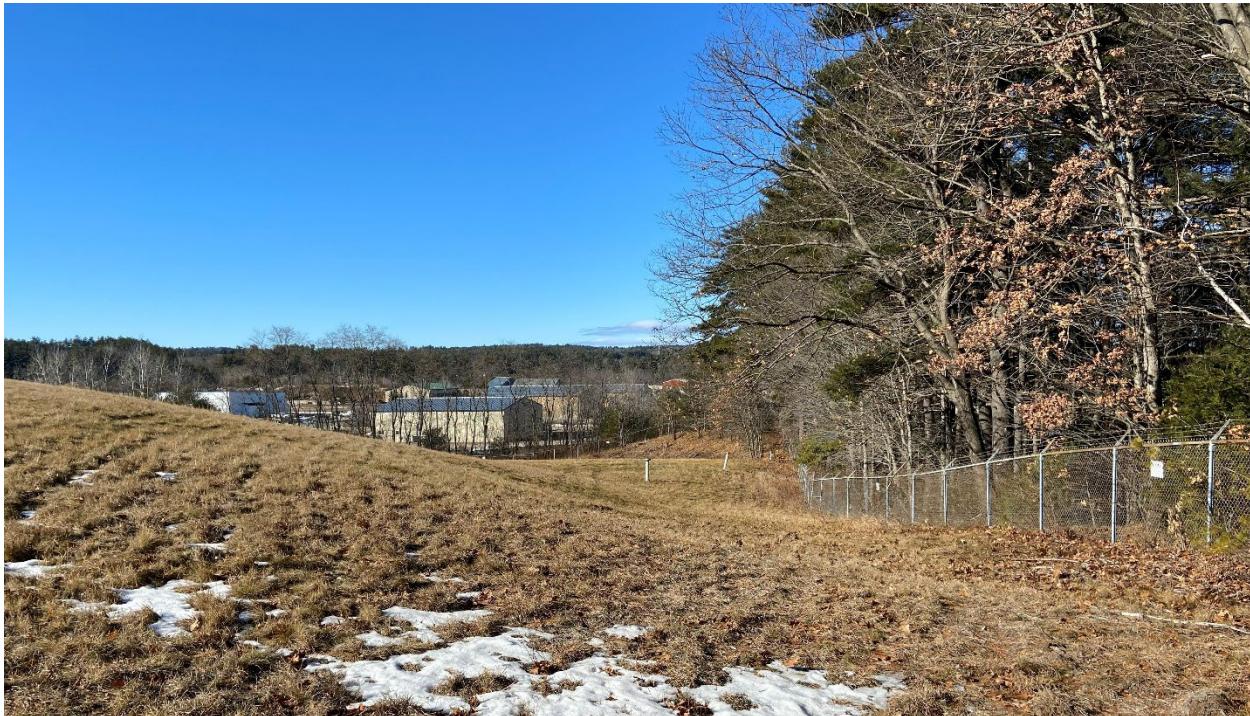
Photo 3: Stable and established slopes in inactive, capped area of landfill. The photograph was taken from near the top of the filled area and looking north.

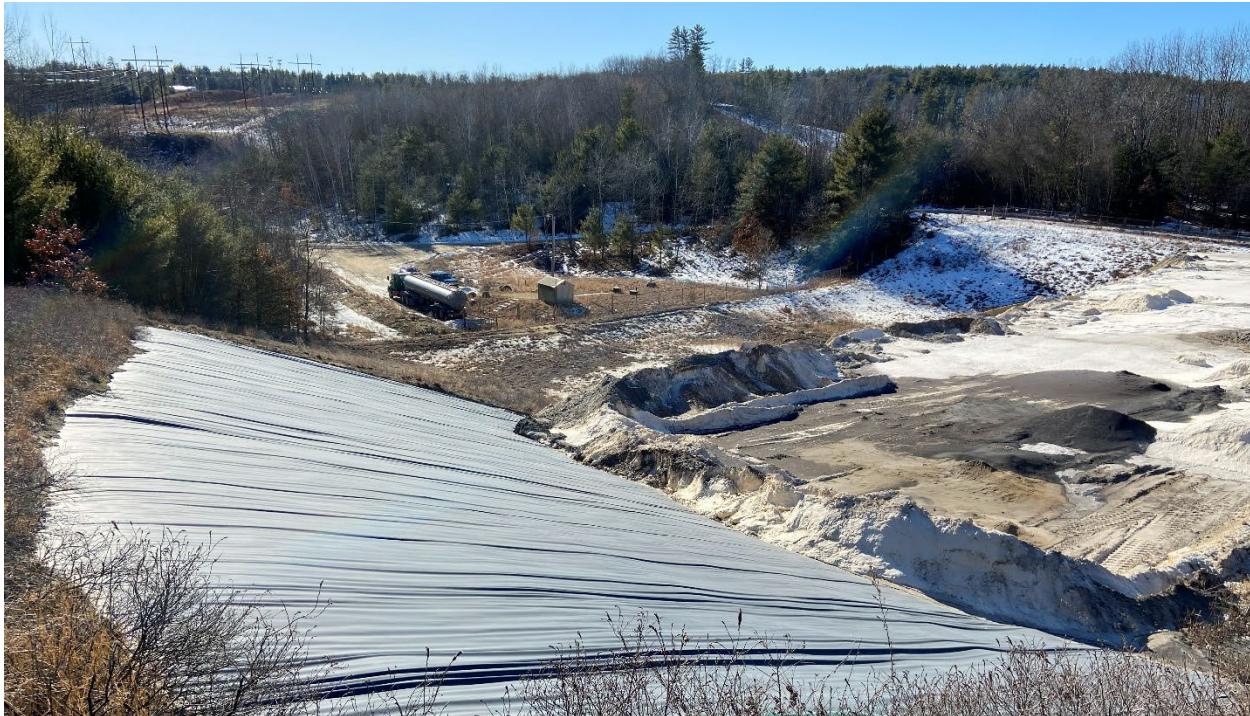
Photo 4: Landfill area not currently being filled (grassy area between leachate collection building and the landfill working face). The liner is visible on the left side of the photograph. The photograph was taken from near the top of the active cell and looking southwest.
